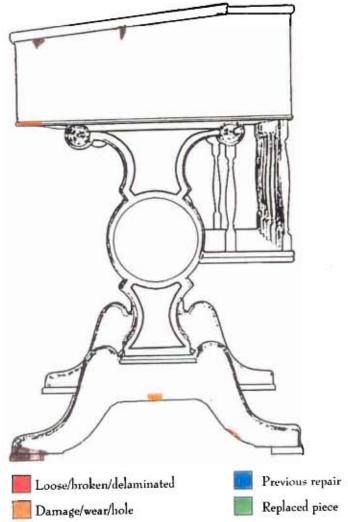
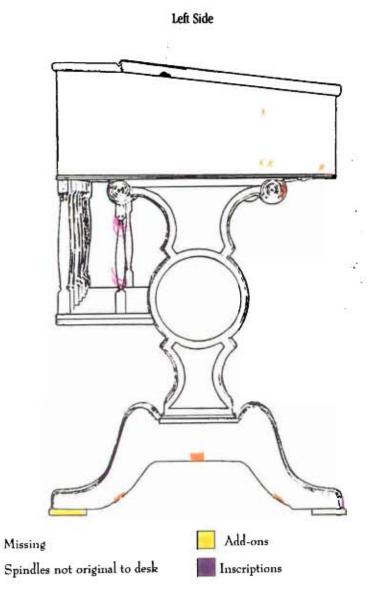
Right Side

Rear View Front View XXII Missing foot Add-ons Loose/broken/delaminated Missing Previous repair Spindles not original to desk Replaced piece Inscriptions Damage/wear/hole
